ADVANCED MATERIALS AND PROCESS
TECHNOLOGY FOR
MECHANICAL FAILURE PREVENTION

Proceedings of the 48th Meeting
of the
Mechanical Failures Prevention Group

Wakefield, Massachusetts
April 19-21, 1994

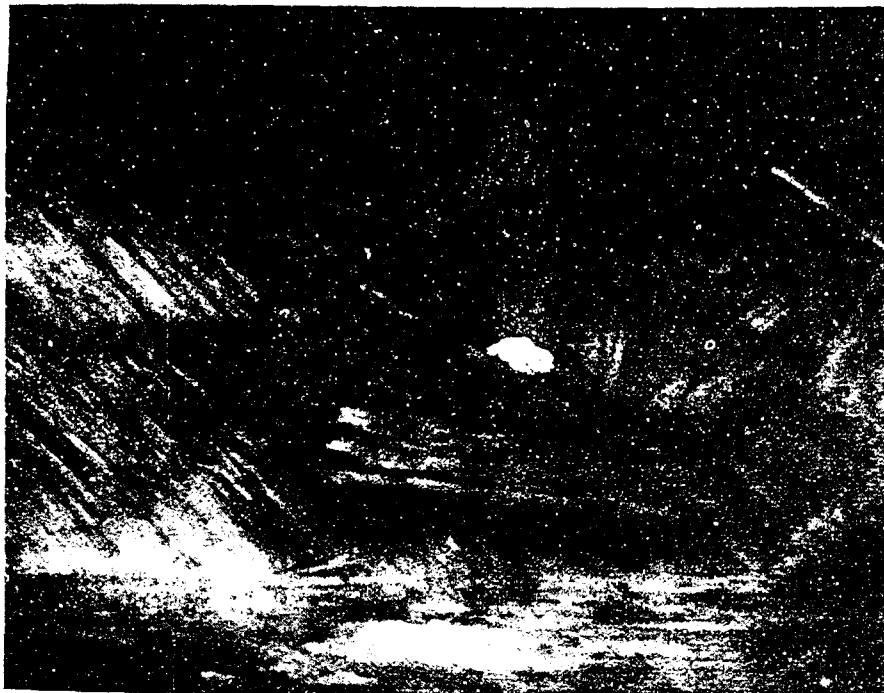
Figure 5. Region of crack initiation in the composite. MAG. 7.5X.

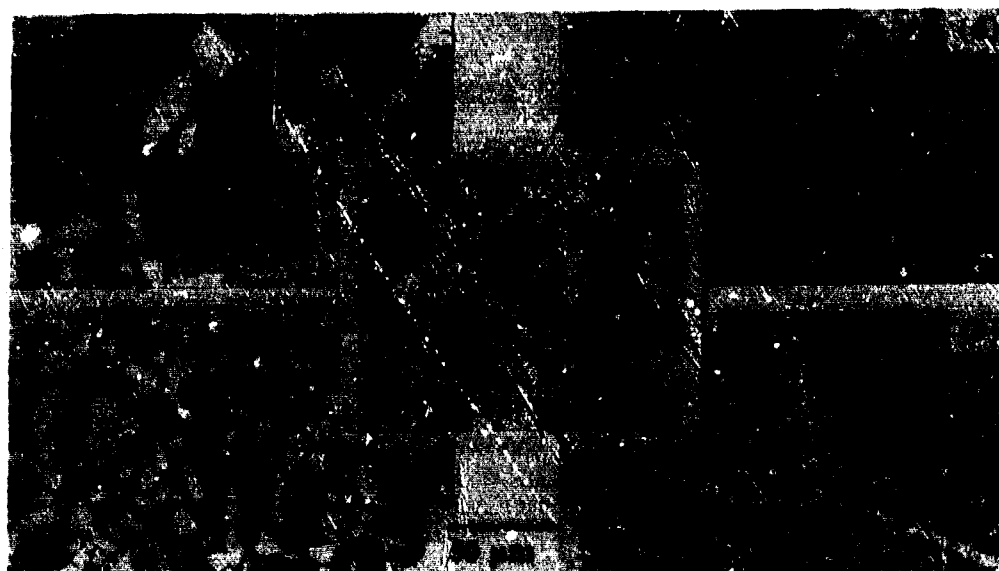
Figure 1: Microstructures of super- α_2 alloy (a) as-ROC'd, (b) heat treated by schedule 1, (c) heat treated by schedule 2, (d) heat treated by scheduled 3, and (e) heat treated by schedule 4.

Materials and Processing: The super- α_2 alloy used in this study is a titanium aluminide alloy, Ti-25Al-10Nb-3V-1Mo (at%) [Ti-14.1Al-19.5Nb-3.2V-2Mo (wt%)] consolidated from plasma rotating electrode processed powder by ROC. The heat treatment schedules listed in Table I were followed to develop the microstructure that optimized the mechanical properties. Also given in Table I is the average aspect ratio (the ratio between the length and the width) of the transformed α_2 phase (except the as-ROC'ed material where the aspect ratio refers to the primary α_2). Heat treatment 1 produced scattered areas of primary α_2 in a mixed α_2/β matrix with well-defined β grains. Heat treatment 2 gave large amounts of equiaxed primary α_2 along with fine acicular α_2 in a β matrix. Heat treatment 3, cycled above and below the β -transus temperature (1363K), resulted in a transformed colony-type α_2 structure with grain-boundary α_2 present. Heat treatment 4 resulted in a fine Widmanstätten appearance. The microstructures of the super- α_2 alloy are shown in Figure 1.
